Project Profile:

Project Name	Paramount Theatre	Specification	Gaco Western BUR-28-U/GS
Location	Seattle, Washington	Area Manager	Dennis Hatfield
Type of Project	Rehabilitate existing roof system	Problem to be Solved	Existing built-up roof blistered & leaking

Leaking roof plagues Seattle's historic Paramount Theatre; Installed GacoFlex roof system stops the leaks for good

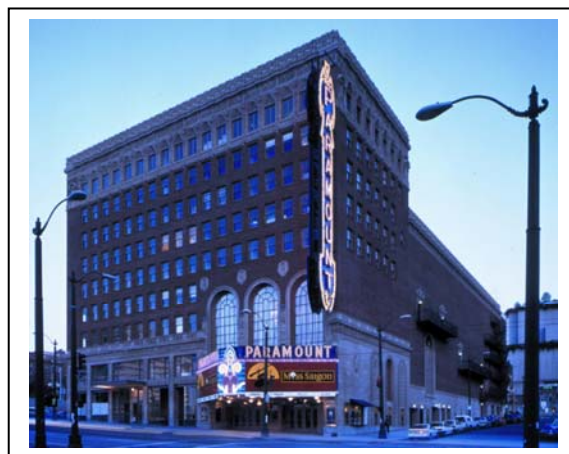
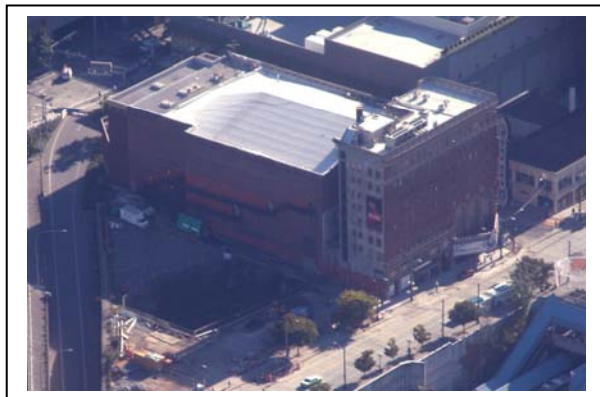
By the summer of 2004, the roof on the theater was also ready for renovation. Leaks had developed over the auditorium section, with one particularly determined leak over the stage area.

The existing 25 year-old built-up roof had been applied in wet weather, resulting in blisters between layers of tar and felt. Before installation work could proceed, blisters were cut out by hand to ensure proper adhesion of the applied coating.

The Walker crew also repaired a crack along the east side of the roof, first removing the flashing and then filling the gap with caulk. Neoprene sheet completed the repair and ensured against further leaks.

With the preparation work completed, GacoFlex E-5320 Epoxy Primer was applied over all roof surfaces. All metal flashing was replaced and taped using GacoFlex U-66 urethane coating and polyester tape.
