Case History

Project Name:	Industrial Manufacturer
Location:	Sunnyvale, CA
Type of Project:	Silicone Roof Application
Specification:	GacoFlex S-20
Area Manager:	Warner Hobart
Customer:	Alliance Roofing, Josh Barthel
Problem to be Solved:	Deteriorating TPO roof

Manufacturer's Failing Roof Restored Using *GacoFlex S-20*

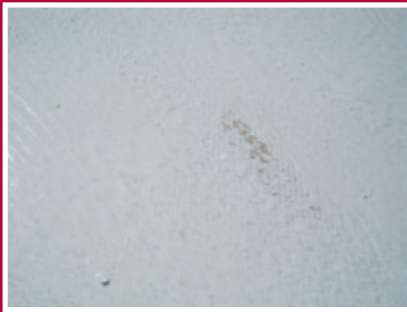
Before applying GacoFlex S-20 the existing roof had significant deterioration

UNIQUE CHARACTERISTICS: A common area where existing single-ply damage was found was at field membrane-to-walkpad attachment points. To eliminate the problem found in these areas, yet still maintain the existing walkpad surface and color, the coating system was overlapped on either side of the walkpad surface, roughly 4", sealing the defective area.

INSTALLATION DETAILS: The existing roof surface was thoroughly cleaned with the use of power-washing equipment, bristle brooms, and a diluted tri-sodium phosphate cleaner before GacoFlex S-20 was applied. Ensuring that the existing roof surface was extremely well cleaned made Alliance Roofing more confident in good bonding adhesion between the new and existing products.

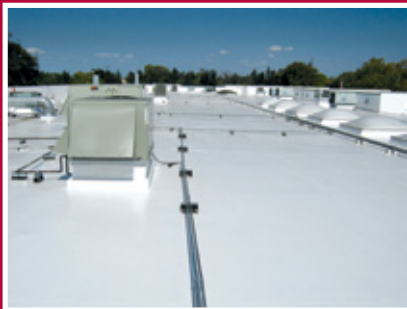
After applying GacoFlex S-20 the roof surface is smooth and defect-free
