Case History

Project Name:	Charles B. Wheeler Downtown Airport
Location:	Kansas City, MO
Type of Project:	Silicone roof application, 91,000 sq ft
Specification:	RC-30-GFS20 (Recoat, 30 dry film mils, GacoFlex S-20)
Contractor:	Clark and Associates
Area Manager:	Adam Scheafbauer
Customer:	Signature Flight Support
Problem to be Solved:	Leaking EPDM roof

Failing Airport Roof Restored Using *GacoFlex S-20*

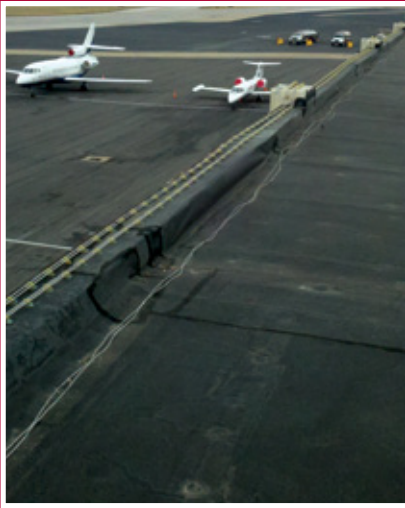
Before applying GacoFlex S-20 the existing roof had significant deterioration

Signature Flight Support operates the center, and they faced a major maintenance problem. The existing roof, a leaking layer of EPDM and a small portion of TPO, meant that the hangar hadn't been dry for the last 22 years. Pollution had literally etched holes in the existing EPDM.

INSTALLATION DETAILS: The roof was laboriously cleaned of all pollutants, areas of rotting plywood deck were replaced, the roof was primed with Gaco Western E-5320 primer, and the GacoFlex S-20 silicone was applied. Signature Flight chose S-20 in white, to reflect sunlight and keep their office area cooler in the summer. After the roof was cleaned seams that were opening were repaired and EPDM coming off a parapet wall was replaced with new EPDM. A complete GacoFlex roofing system that can be warranted includes D-09 detergent, E-5320 primer, and S-20 coating.

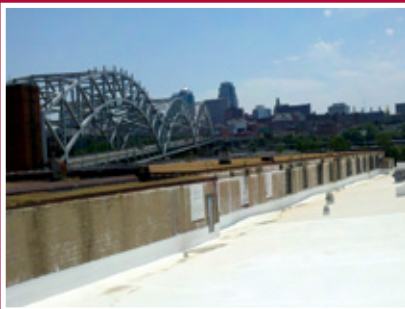
After applying GacoFlex S-20 the roof surface is smooth and defect-free
