Project Profile:

Project Name	Meydenbauer Apartments	Specification	Gaco Western GW-14-UA
Location	Bellevue, Washington	Area Manager	Dennis Hatfield
Type of Project	Repair and recoat existing pedestrian decks	Problem to be Solved	Extensive water damage from failed epoxy decks

Luxury Condominiums Seek Aesthetics and Performance in Repairing Failed Epoxy Decks. Gaco’s Crystal Deck Delivers!

Custom Blend of Quartz Crystals Renews Damaged Decks and Waterproofs Occupied Living Space Below Luxury Condos

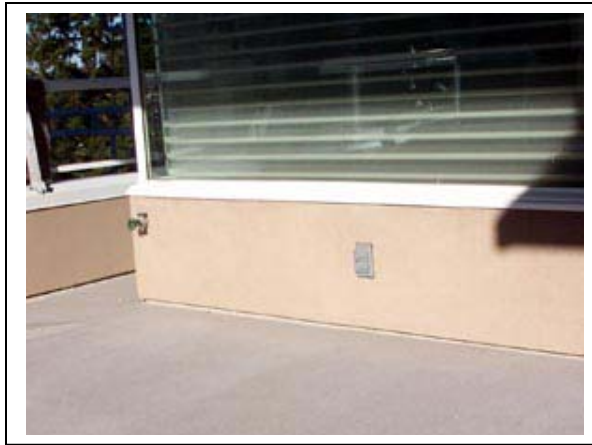
First, the old plywood was removed and new 3/4" AC exterior plywood was installed on the decks. After all joints, flashings and posts had been taped, a base coat of U-66 was applied. Then, colored quartz granules were blended to match the epoxy system. The colored quartz blend was broadcast to excess onto a clear coat of UA-7090 and allowed to dry. The loose granules were blown off, and a final clear topcoat of UA-7090 was applied over the quartz crystals.
