Project Profile:

Project Name	Pemco Insurance Parking Garage	Specification	Gaco Western GW-15-U62
Location	Seattle, Washington	Area Manager	Dennis Hatfield
Type of Project	Install Fast-Set Urethane Parking Deck System	Problem to be Solved	Failed Traffic Deck leaking and peeling

GacoFlex Fast-Set Urethane Traffic Deck System Completely Installed in a Weekend—No Interruption to Building Occupants

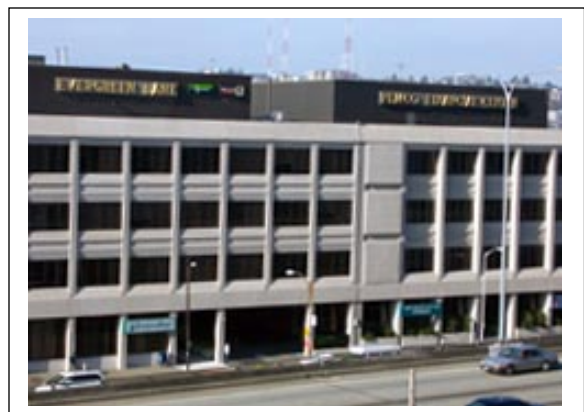
The Pemco Insurance building in Seattle, Washington had a problem. The moisture-cured parking deck system they had installed had failed in many areas. For several years, Pemco's maintenance staff had attempted to patch the failed areas with the same material, but the patches also failed. Facility Manager

Paul Chin wanted to remove the failed membrane and install a high-quality GacoFlex system.

The entire deck was powerwashed to remove loose coating. Areas of damaged concrete were filled with a mixture of E-5481 and sand. Then the main deck was primed with GacoFlex U-5677 and allowed to cure for 4 hours before application of the GW-15-U62 system.
