Project Profile:

Project Name	Briarcliffe College	Specification	Gaco Western SI-22-GS
Location	Bethpage, New York	Area Manager	Tony DeVito
Type of Project	Repair and waterproof 109,000 square foot roof	Problem to be Solved	Cracked and leaking foam roof

Long Island's Briarcliffe College has thorny roof problem; GacoFlex Silicone coating smoothes everything out

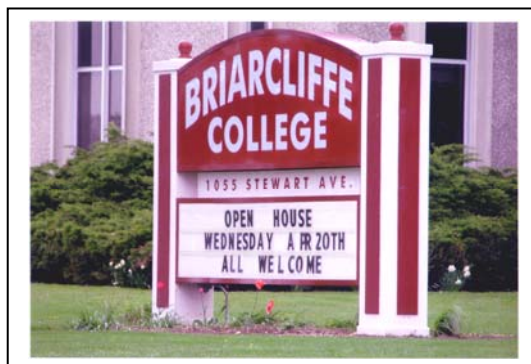
“The result was a beautiful leak-free roof over the heads of students and staff.”

In the summer of 2005, the college was looking for a way to extend the life of the building's 109,000 square foot roof. The 18-year old foam roof was performing fairly well, although leaks had developed around some air-handling units.

First, the roof was power washed to clean off dirt and grime, and give a better idea of the work needed. The power washing revealed cracks and missing chunks of foam in the existing roof system.

The existing system was removed around the air handling units, replaced with Gaco Western's 273 polyurethane foam, and carefully flashed to prevent future leaks. Holes in the foam were also patched with Gaco 273 foam and then the excess shaved off to bring the new foam level with the existing roof.

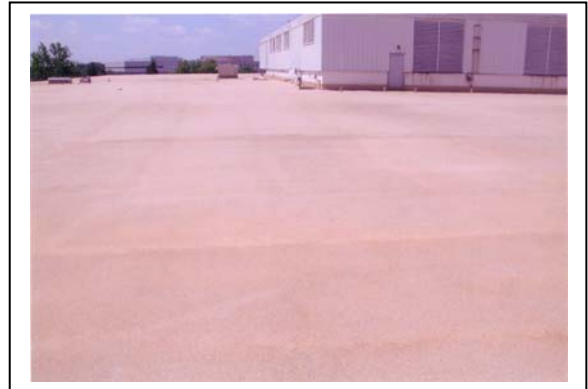
The roof work was completed by the middle of June 2005. The result was a beautiful leak-free roof over the heads of Briarcliffe students and staff.

With the detail work completed, application work could begin. As the first step, the S-1011 gray silicone basecoat was spray-applied and allowed to cure.

Next, the S-1048 tan topcoat was spray-applied, and granules were broadcast into the wet coating. The tan color of the topcoat had been custom matched to provide a perfect complement to the broadcast granules. The tan and brown mixture of granules came from a Texas quarry, and provided the perfect finishing touch to the project.
