Project Name	455 Capitol Mall Complex	Specification	Gaco Western GW-15-UBU
Location	Sacramento, California	Area Manager	Warner Hobart
Type of Project	Install Urethane Traffic Deck System	Problem to be Solved	Leaking BUR under 4-inches of asphalt

New Traffic Deck System Waterproofs Capitol Mall Complex

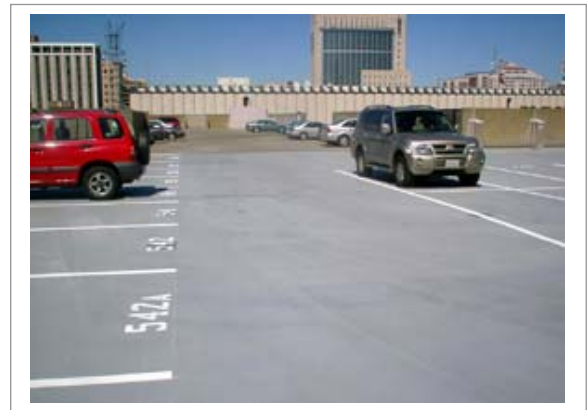
The 455 Capitol Mall Complex in Sacramento, CA is a large business facility that houses law practices, accounting firms, and other professional offices. A 10,500 square foot parking deck on the roof consisted of built-up-roofing covered with 4-inches of asphalt paving. The roof had developed leaks and required resurfacing and waterproofing.
