Project Profile:

Project Name	MUNI Bus Barn	Specification	Gaco Western GW-15-UBU
Location	San Francisco, California	Area Manager	Warner Hobart
Type of Project	Install Urethane Parking Deck System	Problem to be Solved	Daily Traffic From Articulated Buses and Industrial Forklifts

Bus Maintenance Facility Demands Tough Parking Deck System; Only Gaco Can Meet the Challenge

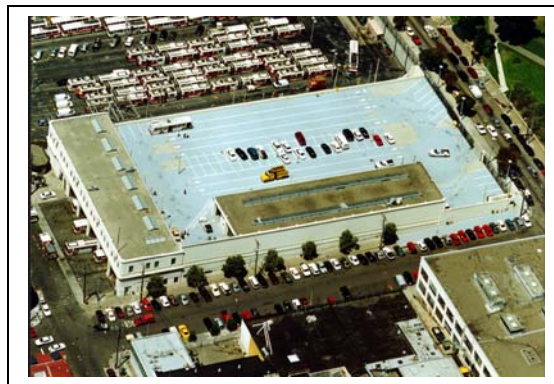
Gaco Western traffic deck specification, GW-15-UBU, was applied, including primer, urethane coating, walnut shell texture, and sealer.

Each manufacturer would lay down a sample, installed according to submittal spec. Then, two wear tests would be conducted. First, an industrial forklift would be parked with its front wheels over the sample; the wheels would be turned to a hard right, followed by a hard left. Second, the same "chalk-to-chalk" test would be performed with a 20-ton articulated bus. The only requirement for passing the test was that the coating had to remain adhered to the substrate.

Initially 3 rotations were performed. Two of the coating manufacturers were already out of the game—the coatings had torn away under the pressure and heat from the tire rotations. After 6 rotations, the third manufacturer was also eliminated, leaving only Gaco Western. Thirteen more rotations were performed—and only Gaco's system withstood the punishing test.

- High resistance to heat stress load
- Excellent adhesion due to sealer primer system
- Walnut shell aggregate instead of sand (sand is likely to kick out, then loose grit damages the coating; walnut shell wore evenly with the coating, and did not scuff out or damage the coating).
